ELIMINATION OF CREVICE SEAL & O-RING

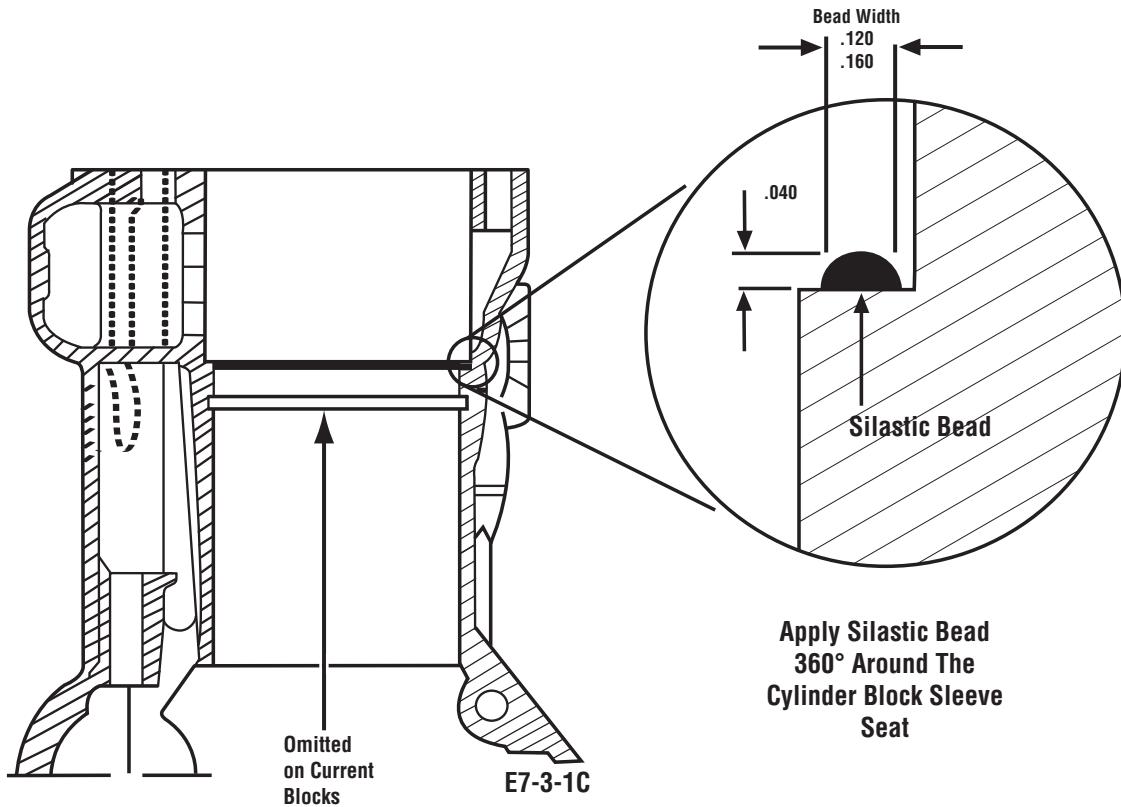
1. Some E-7 Engines have an O-ring groove below the cylinder sleeve seat, and some do not. It has been determined that this O-ring is not required as long as silastic is used at the sleeve shoulder.
2. Clean liner & block to assure removal of all contamination & oil.
3. Apply a .120 to .160 inch bead of RTV Silicone (PAI BSR-0385, Dow Corning #RTV732, or General Electric #RTV103 Silastic Sealant) to the cylinder block sleeve shoulder 360°. **DO NOT** use excessive amount. Sealant must be applied just prior to installation of the sleeves to prevent partial curing and questionable sealing and bonding.

4. From the beginning of E7 PLN and E-Tech™ engine production, a crevice seal, similar to an o-ring, was installed in the groove located in the outside diameter of the cylinder sleeve, near the sleeve top.

It has been determined, however, that the crevice seal is not necessary. Therefore, effective approximately December 1998(engine serial number series 8Y), the crevice seal is no longer used in production engines.

Additionally, effective January 1999 (engine serial numbers series 9A), the crevice seal groove in the cylinder sleeve has been eliminated.

Effective with these production changes, cylinder sleeve part number ESL-8288 for service use will not have the crevice seal groove, and it is recommended that use of the crevice seal be discontinued in all engine repairs or rebuilds, whether or not the liner has a crevice seal groove.

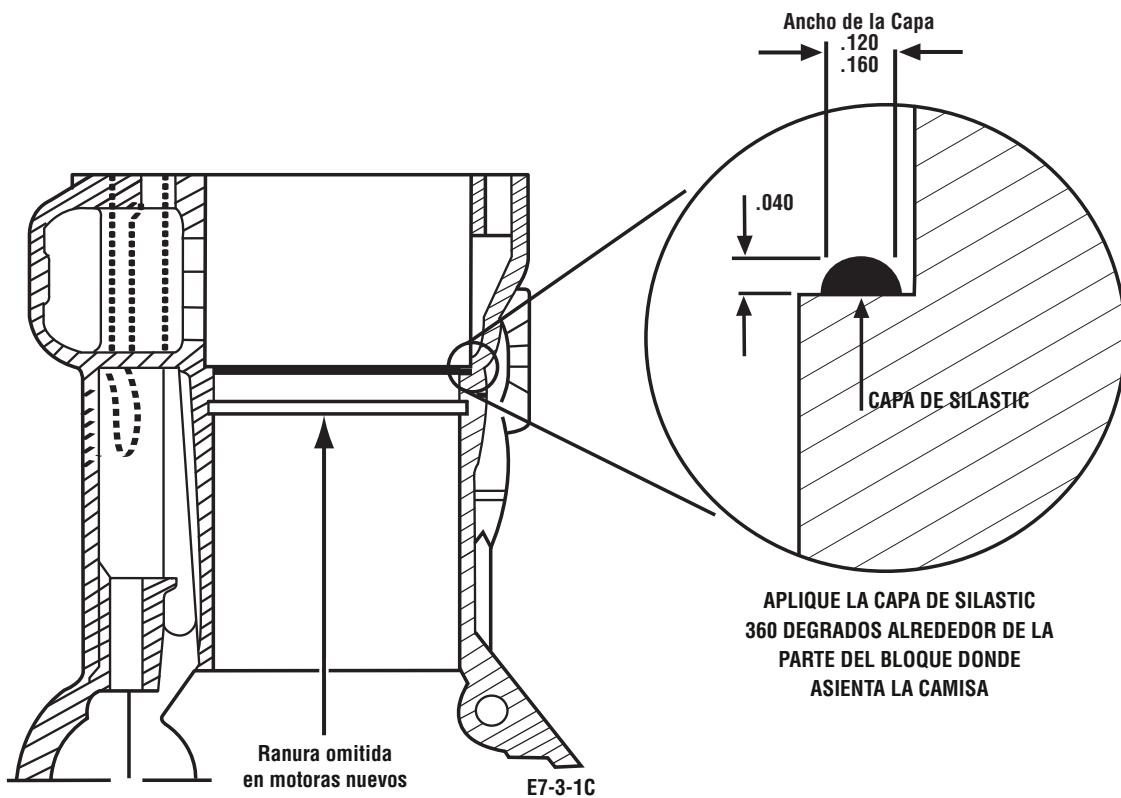
1. Algunos motores E-7 tienen una ranura para un anillo “O” debajo donde la camisa asienta en el bloque y otros no. Ha sido decisión que este anillo “O” no será necesario si se utiliza una capa de Silastic en el bloque donde asienta la camisa.
2. Limpie la camisa y el bloque para asegurarse de que toda contaminación y aceite han sido removidos.
3. Aplique una capa de Silicona RTV (PAI BSR-0385, Dow Corning #RTV732, o General Electric # RTV103) de un ancho entre 0.120" y 0.160" 360° alrededor de la parte del bloque donde asienta la camisa. No use cantidades excesivas de RTV. El sellante debe ser aplicado inmediatamente antes de la instalación de las camisas para prevenir un curado parcial y una unión y sellado dudoso.

4. Desde el principio de la producción de motores E7-PLN y E-Tech, un sello similar a un anillo “O”, fué instalado en la ranura del diámetro exterior de la camisa de cilindro, cerca de su parte superior.

Sin embargo, se ha determinado que este sello no es necesario. Por consiguiente, desde Diciembre de 1998 (motores con números de serie 8Y) el sello no se utilizará más en la producción de motores. Adicionalmente, efectivo a Enero de 1999 (motores número de serie 9A) la ranura en la camisa para instalar el sello ha sido eliminada.

Con estos cambios en producción, la camisa número de parte ESL-8288 no tendrá la ranura para el sello. Se recomienda que el uso del sello sea descontinuado en todas las reparaciones o reconstrucciones de motor, sea que la camisa tenga o no la ranura para el sello.
