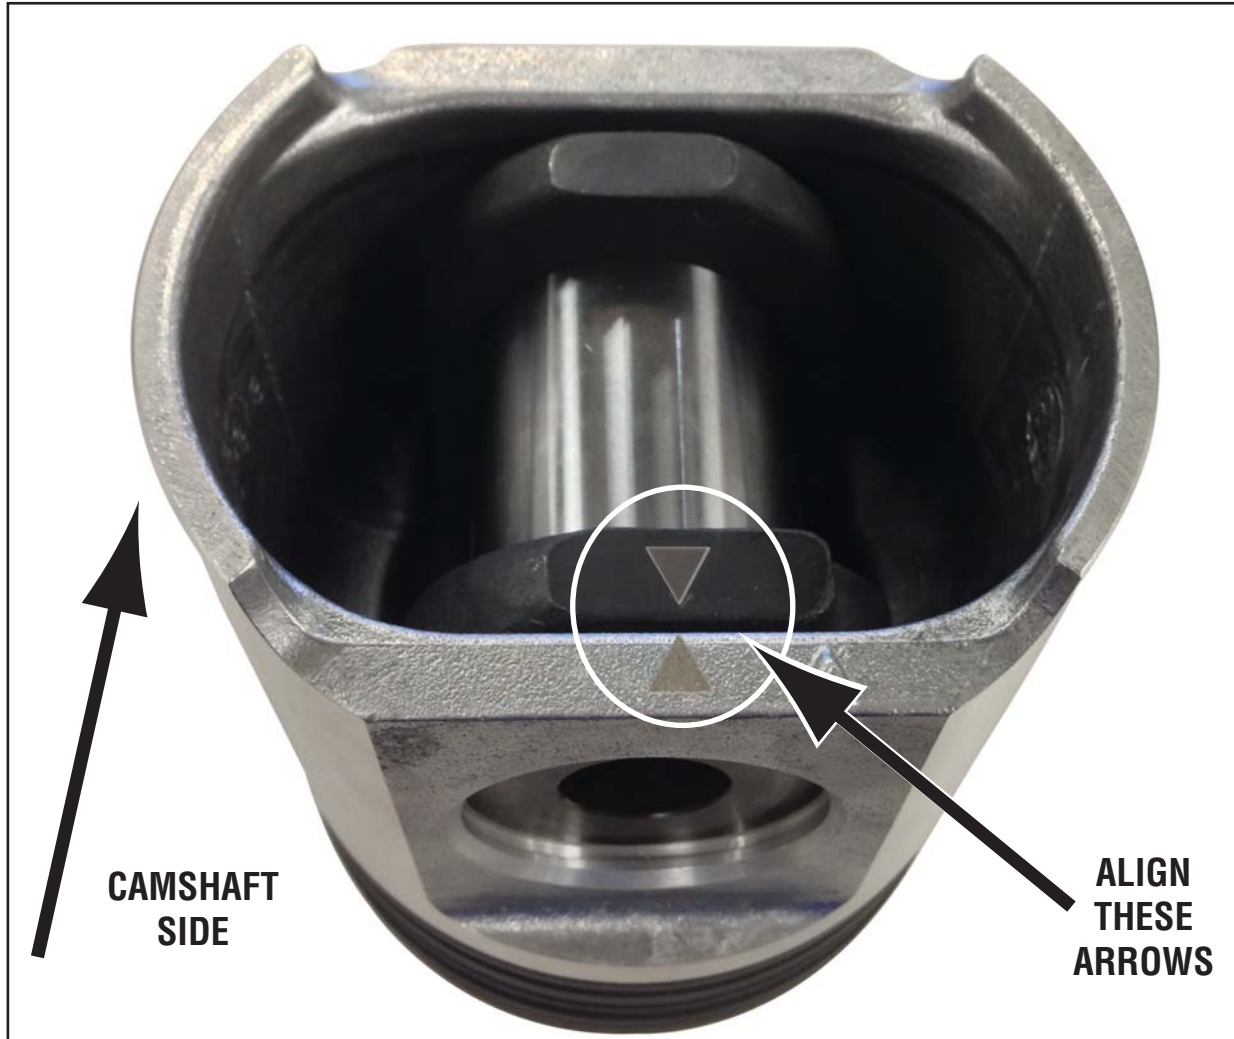
Figure 1

The piston assembly contained in this package was designed using an offset pin location. Because of this, great care should be taken to ensure the piston skirt and crown are properly oriented to each other before installation. To this end, there are arrow markings on the bottom of both the skirt and the crown, as shown in Figure 1. Please ensure that these arrows are on the same side of the assembly and pointing towards each other. Failure to do so will cause catastrophic engine damage. PAI Industries assumes no responsibility for damage caused by the negligence of this requirement.

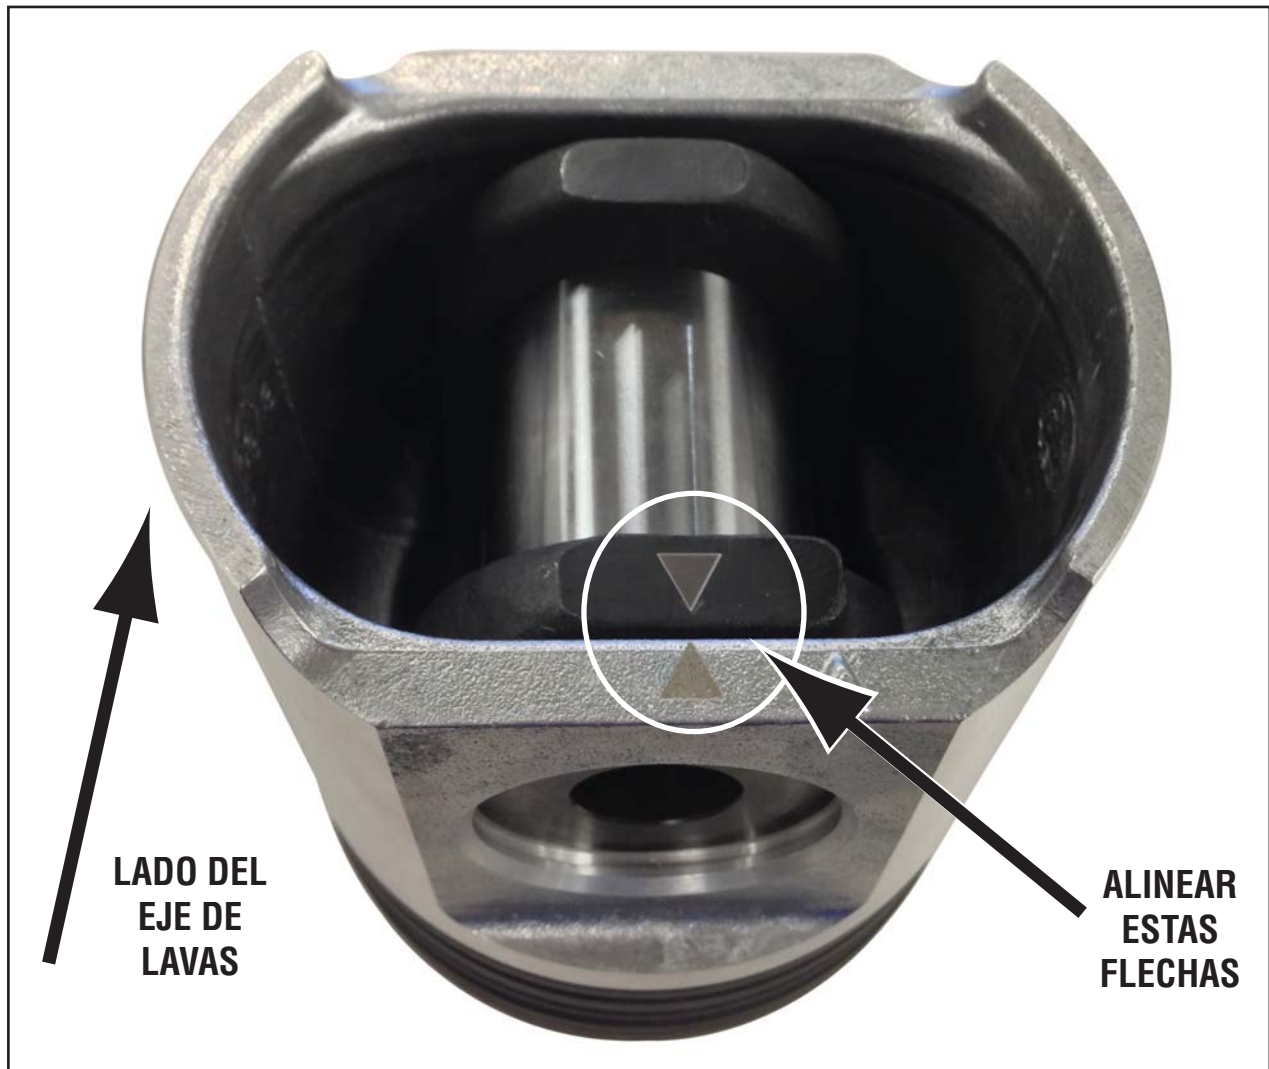
Figura 1

El conjunto de pistón en esta caja fue diseñado para usar su pasador 'fuera de centro'. Por esta razón, debe tomarse sumo cuidado al orientar correctamente la corona con su falda antes de ser instalado en el motor. Para este propósito hay flechas en la parte inferior tanto de la corona como de la falda, según indicado en la Figura 1. Debe asegurarse que ambas flechas estén del mismo lado y apuntando una a la otra. De no ser así, ocurriría un daño catastrófico al motor. PAI Industries no asume responsabilidad por daños causados por negligencia a este requisito.
